# HAND GAUGES FOR INSPECTION OF SWITCH POINTS TO PREVENT WHEEL CLIMB

Researchers look to techniques established abroad to develop improved tools for switch inspection in order to reduce wheel climb derailments.

by Dr. Allan M. Zarembski PE, FASME Hon. Mbr. AREMA, research professor and director of Railroad Engineering and Safety Program, University of Delaware and Brad Kerchof, director Research & Tests, Norfolk Southern Railway

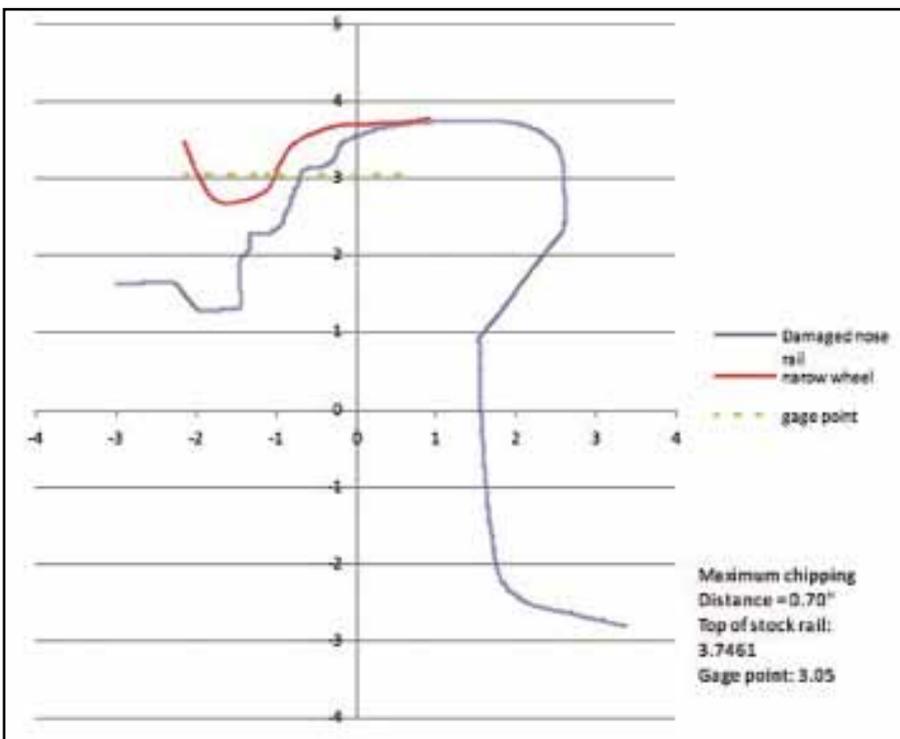
Opposite page:  
**Figure 1**, AAR 1B narrow flange  
 wheel profile on damaged  
 switch point of Number 10 turnout.<sup>4</sup>

files (both narrow and wide flange) and measured switch point profiles. This included analysis of the location of the gauge point of wheel (where radius reverses on wheel flange), where there is the greatest potential for wheel climb. As illustrated in Figure 1, for the AAR 1B narrow flange wheel, the

analysis determined that the distance from top of stock rail to the point of potential wheel climb should be approximately 0.70 inches and that the gauge face angle should be 70 degrees.

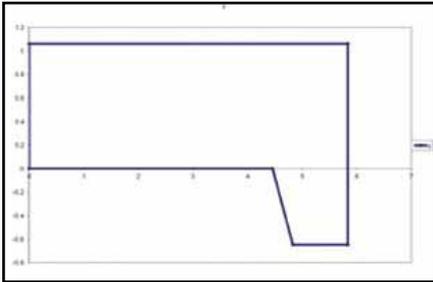
This page: Left, **Figure 2**, Chipped  
 Point Gauge. **Figure 3**,  
 Chipped Point Gauge in field.

The shape of the Chipped Point Gauge is shown in Figure 2. Figure 3 shows how this gauge is used in the field;

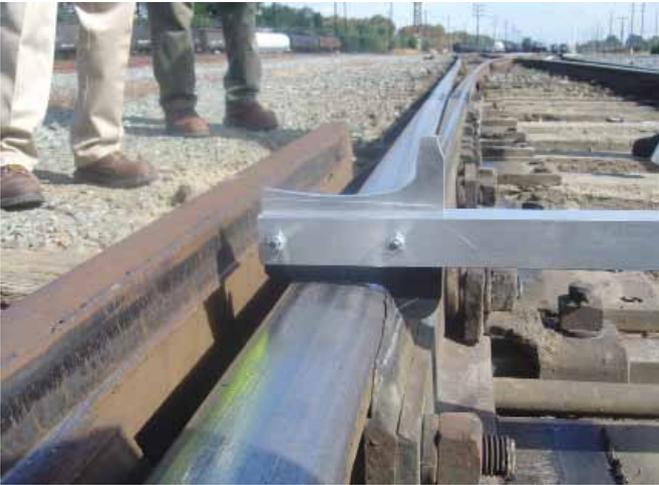
Left, Figure 4, new AAR1B Wheel Profile Gauge in bottom measurement position. Severely worn AAR 1B wheel profile in top (inactive) position. Figure 5, contact below 60-degree mark on new AAR 1 B Wheel Flange Gauge.

including a new AAR 1B profile (the bottom gauge in Figure 4), a moderately worn AAR 1B profile and a severely worn AAR 1B profile (the top gauge in Figure 4).

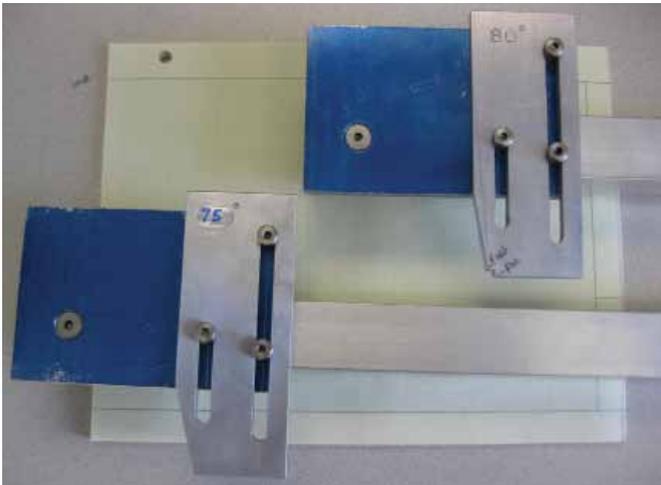
Left, Figure 6, adjustable 80-degree notched gauge (top) and 75-degree gauge (bottom). Figure 7, 80-degree worn wheel gauge with unsafe contact.

(see Figure 6). The 80-degree gauge face angle was judged to be too steep, but not by much (the gauge face angle of a new switch point for NS standard plan is 78 degrees). To address this, the team added a small square notch to the bottom corner of the 80-degree gauge, to make the 80-degree gauge face angle gauge less likely to fail a good switch point. A “pass” edge and a “fail” edge were marked on the notch. However, it was judged that this gauge is hard to see (the notch is very small), and too lenient (allows acceptance of potentially failing point). The gauge with a 75-degree gauge face angle performed better, condemning fewer good switch points. Fig-

The team looked at several different gauge face angles and finally selected 80 degrees and 75 degrees for further testing

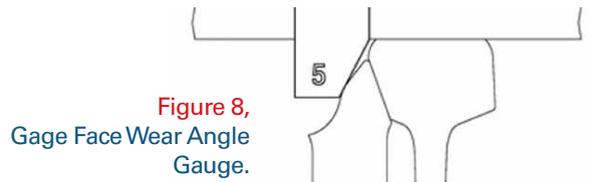
The Gage Face Wear Angle Gauge, illustrated in Figure 8, has a 32-degree gauge face angle and specifically addresses the potential for wheel climb under high L/V conditions.

The fourth gauge looked at wheel climb at a switch point with a significant gauge face wear angle. Studies have indicated that development of a significant angle between the gauge face and vertical creates the potential for a wheel to climb, particularly in an unlubricated condition with a high coefficient of friction.<sup>5</sup> For example, for a very dry condition (corresponding to a coefficient of friction of 0.5), a 28-degree gauge face wear angle requires only an L/V level of 0.70 to initiate wheel climb.

Noting that the traditional Nadal wheel climb threshold is 0.8 and that the majority of the measured maximum L/V ratio values are of the order of 0.8 or less, a wear limit on the order of 26 degrees to 33 degrees is appropriate. This is consistent with the maintenance values adapted by several
